Dream Team

With design-build cooperation, a three-story addition to a hospital in Albuquerque, NM is a smooth operation.

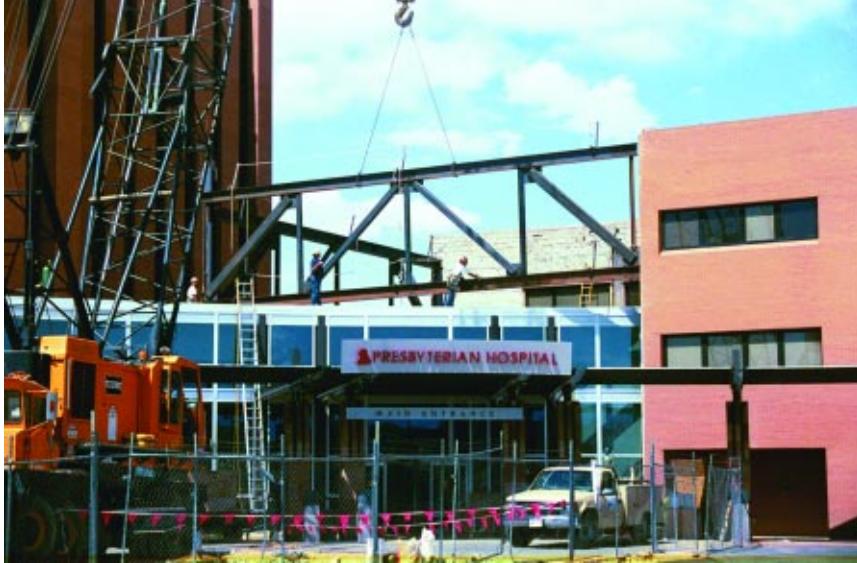
Framing for a new three-story pedestrian bridge over the existing lobby is erected.

The new expansion also features a three-story pedestrian bridge that connects to an existing seven-story medical office building. The bridge goes over the top of the existing hospital's main entry lobby. The owner wanted to minimize any new columns in that area, so an offset vertical truss column was designed to support the bridge. This truss column was placed outside of the lobby area, and then steel beams cantilevered off of the side of the truss column to support the bridge floors. The truss column measures 16' wide by 72' tall.

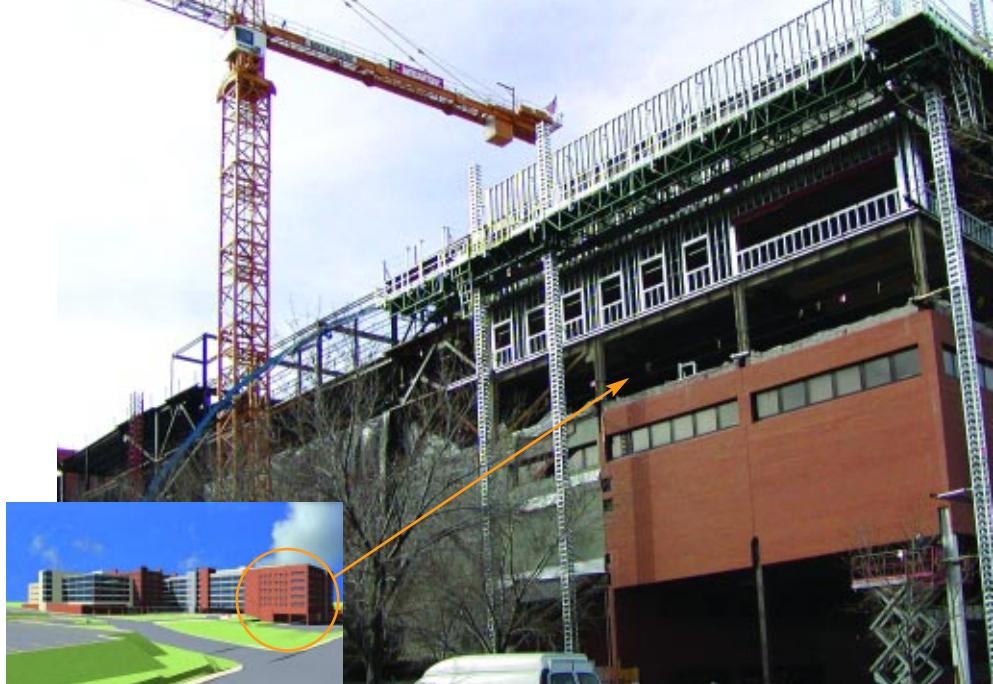
Three stories were added on top of an existing four-story wing.

Steel was chosen in part to meet the project schedule, and in part because the existing tower was steel. The renovation used 1,200 tons of structural steel to add 150,000 sq. ft to the building. The gravity framing of the new construction consists of steel joists and

wide-flange beams at the roof, steel wide-flange composite beams and girders at the elevated floors, and wide-flange columns. This system matched the existing building's structural system below. The new columns were connected to the existing columns. As part of the original construction, the existing columns were extended above the existing roof level in preparation for a future addition. Lateral framing consists of steel HSS braces, and wide-flange columns and beams. The steel structure was fire-protected with a two-hour cementitious fire-protective coating.
